**Flood Control Project Maintenance
Levee Inspections****LMA District Cover Sheet****Spring 2011 Levee Inspection Results****Sacramento Maintenance Yard Willow Slough Bypass**

Levee Inspection Report By Mile - Spring 2011

Waterway						Bank	Unit Miles	Inspection Start/End	Inspector
Unit No. 01 Willow Slough Bypass or North Levee						Left	5.09	03/10/2011 03/10/2011	John Williamson

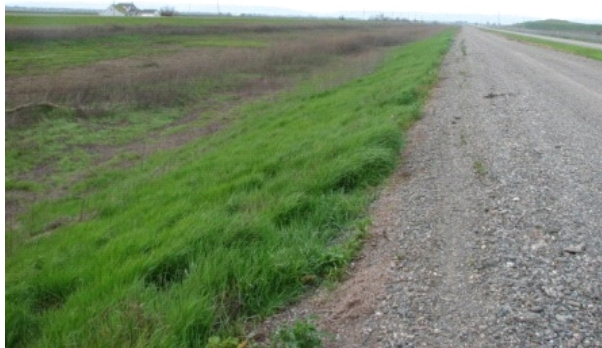
Levee Mile Report Line	3
Start Levee Mile	0.68
End Levee Mile	0.68
Location	Water Side
Category	Earthen Levee
Item	Vegetation

This the waterside view of Willow Slough.

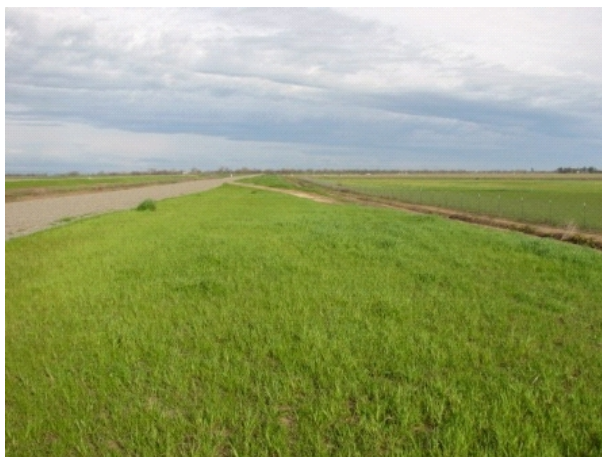
Levee Mile Report Line	4
Start Levee Mile	3.83
End Levee Mile	3.83
Location	Land Side
Category	Earthen Levee
Item	Vegetation

The landside upstream of County Road 102.

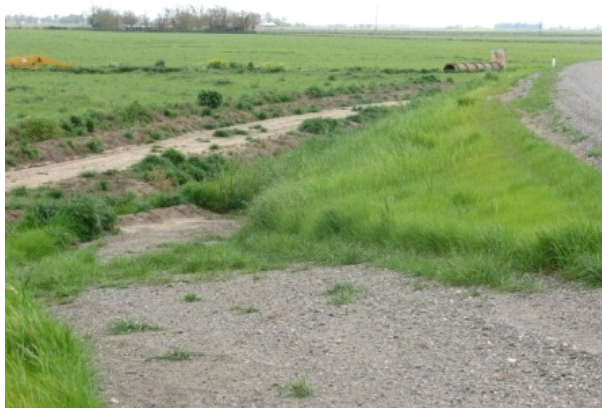
Levee Mile Report Line	5
Start Levee Mile	4.16
End Levee Mile	4.63
Location	Land Side
Category	Earthen Levee
Item	Encroachments

agricultural ditch across ramp at toe

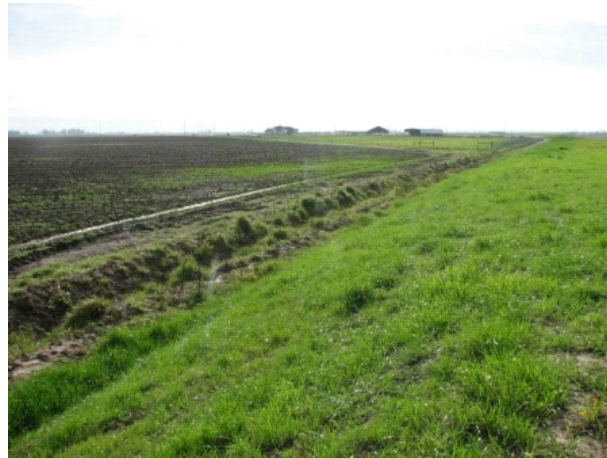
Levee Mile Report Line	5
Start Levee Mile	4.16
End Levee Mile	4.63
Location	Land Side
Category	Earthen Levee
Item	Encroachments

The aricultural ditch runs along the toe of the levee.

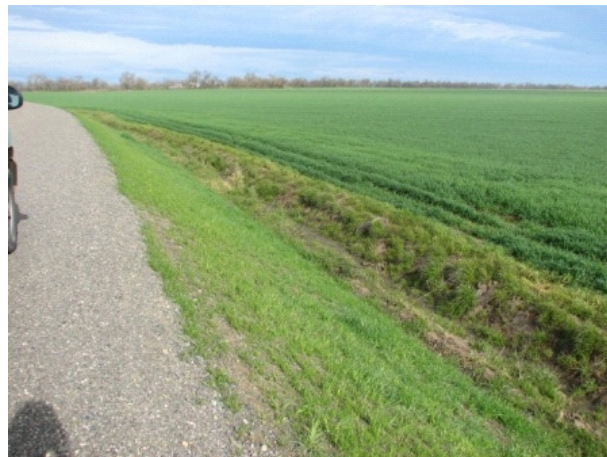
Levee Mile Report Line	5
Start Levee Mile	4.16
End Levee Mile	4.63
Location	Land Side
Category	Earthen Levee
Item	Encroachments

Another view of the aricultural running along the toe of the levee.

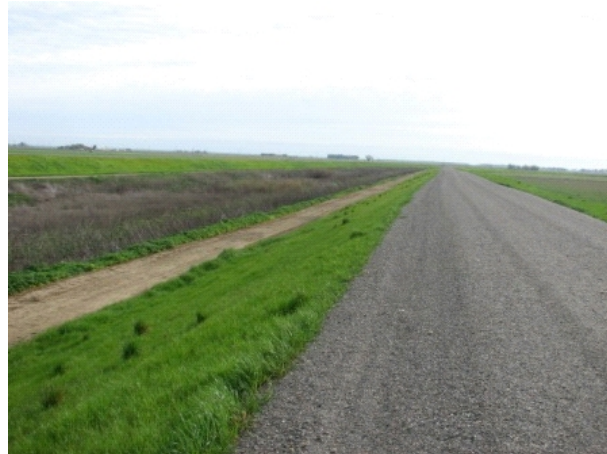
Levee Mile Report Line	1
Start Levee Mile	0.25
End Levee Mile	0.25
Location	Water Side
Category	Earthen Levee
Item	Vegetation

The grasses on the waterside of Willow Slough.

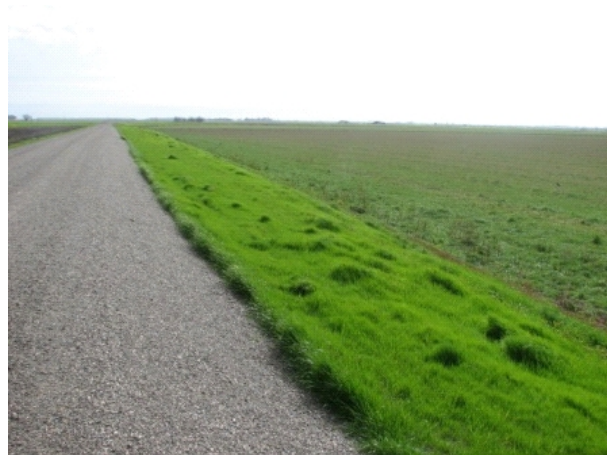
Levee Mile Report Line	2
Start Levee Mile	0.25
End Levee Mile	0.25
Location	Land Side
Category	Earthen Levee
Item	Vegetation

This view is the landside grasses on the slope of Willow Slough.

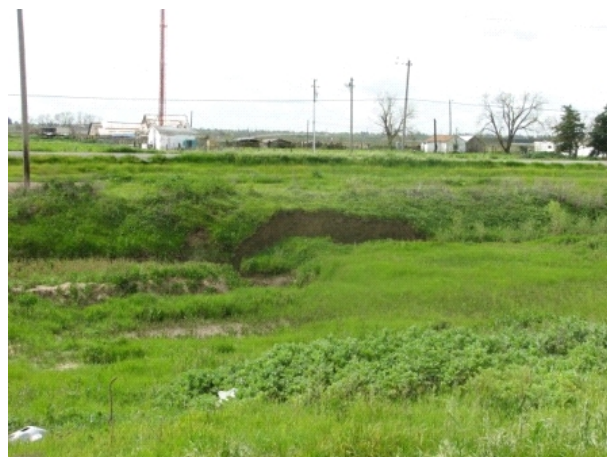
Levee Mile Report Line	3
Start Levee Mile	1.71
End Levee Mile	1.71
Location	Water Side
Category	Earthen Levee
Item	Erosion / Bank Caving

The erosion on the south side of the levee channel is encroaching into the toe road.

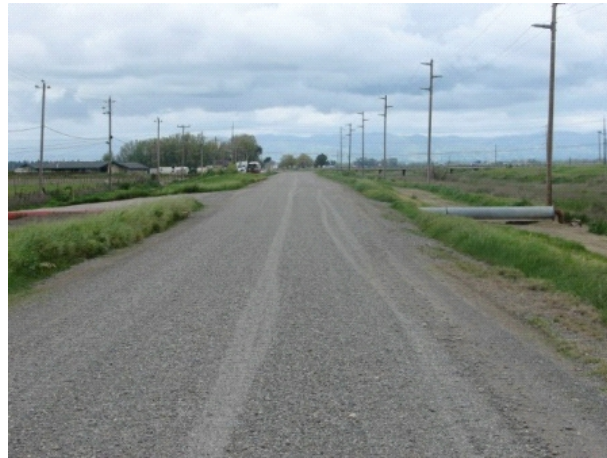
Levee Mile Report Line	4
Start Levee Mile	1.87
End Levee Mile	1.87
Location	Water Side
Category	Earthen Levee
Item	Encroachments

A pipe crossing thru the levee and blocking toe road.

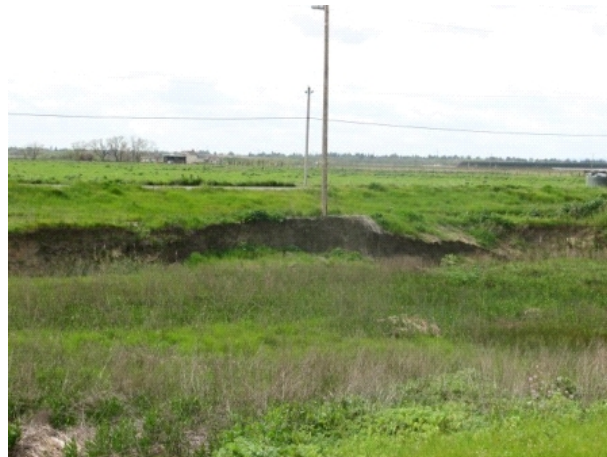
Levee Mile Report Line	5
Start Levee Mile	1.97
End Levee Mile	1.97
Location	Water Side
Category	Earthen Levee
Item	Erosion / Bank Caving

The erosion on the south side bank of the channel is encroaching into the power pole and toe road.

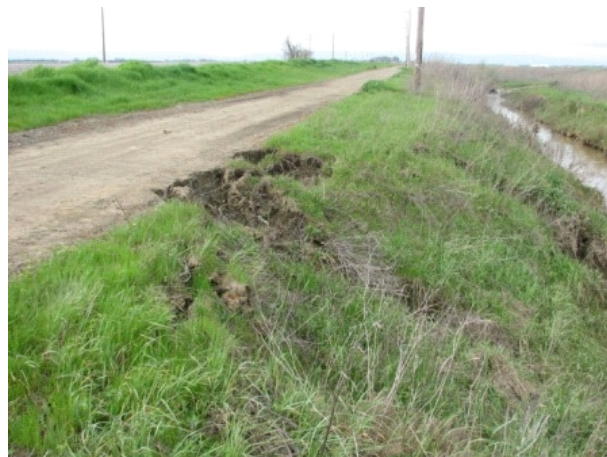
Levee Mile Report Line	6
Start Levee Mile	2.66
End Levee Mile	2.66
Location	Water Side
Category	Earthen Levee
Item	Erosion / Bank Caving

The erosion in the channel is starting to encroach into the toe road.

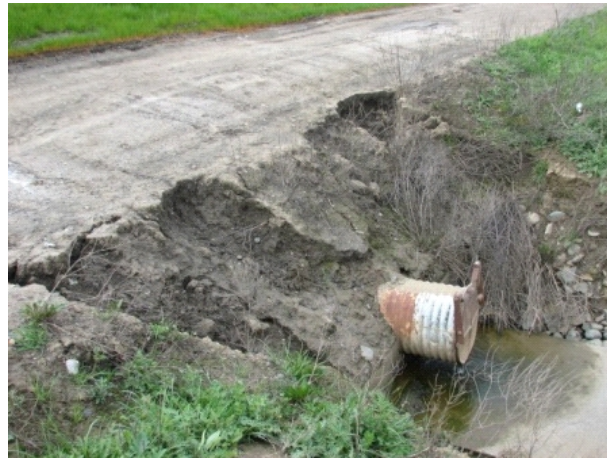
Levee Mile Report Line	7
Start Levee Mile	2.90
End Levee Mile	2.90
Location	Water Side
Category	Earthen Levee
Item	Erosion / Bank Caving

7	2.90	2.90	Earthen Levee	Erosion / Bank Caving	WS	M	Note and monitor erosion site. Inspector Comments: The site has a discharge pipe and has begun eroding around the pipe. It is also eroding into the toe road.	38.589707 ° -121.705044 °	38.589707 ° -121.705044 °	10 Y
8	3.56	3.56	Earthen Levee	Encroachments	LS	PO	Buildings Inspector Comments: control structure Davis Drain block building	38.589657 ° -121.692850 °	38.589657 ° -121.692850 °	2 Y
9	6.71	6.84	Supplemental	USACE Erosion Survey	WS	M	Inspector Comments: 2009: no berm, 2:1 slope, no stability issues, clays and silts, 0.2 ft/s [2009 SiteID:WSB_6-9_R]	38.578867 ° -121.647422 °	38.577028 ° -121.647233 °	7

The slope around the discharge pipe is eroding the toe road. Rip rap could be placed around the pipe and resloped.

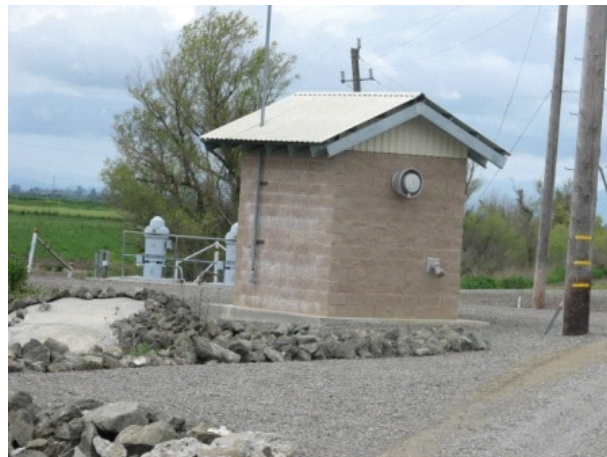
Levee Mile Report Line	8
Start Levee Mile	3.56
End Levee Mile	3.56
Location	Land Side
Category	Earthen Levee
Item	Encroachments

City of Davis pumping plant
